DYNAMIC TESTS OF AN ENERGY ABSORBING BARRIER EMPLOYING SAND-FILLED FRANGIBLE PLASTIC BARRELS

RESEARCH REPORT

NO. M&R HRB 636405-4

Prepared in Cooperation with the U.S. Department of Transportation, Federal Highway Administration January, 1972

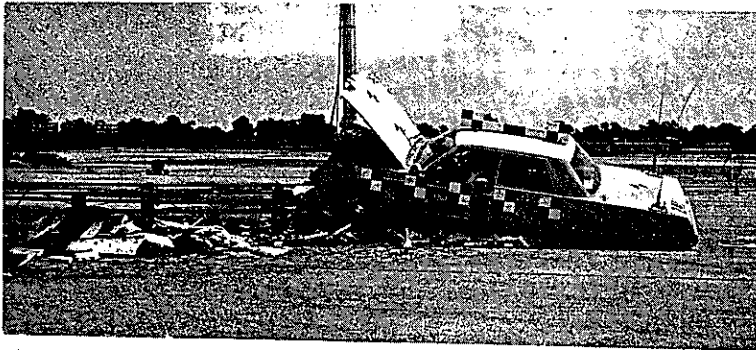
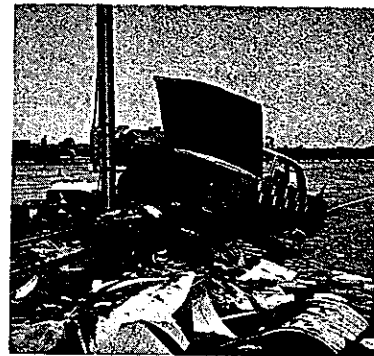
See Plate 3, page 15, for a summary of the test results. The vehicle, traveling 58 mph, impacted the barrier head-on and plowed through the entire barrier (Figures 5 and 6). The vehicle axis was one ft. to the left of the barrier axis at the time of impact. About 3-4 feet in front of the bridge railing, the vehicle ramped up on barrier debris and came to rest on the bridge rail just in front of the camera tower 24 ft behind the nose of the barrier. As it ramped up, the vehicle tilted sharply in a counterclockwise direction, since the left front wheel was off the bridge rail, and almost turned over (Figure 7) before returning to its final position. The left rear fender was flush with the ground when the vehicle came to rest.

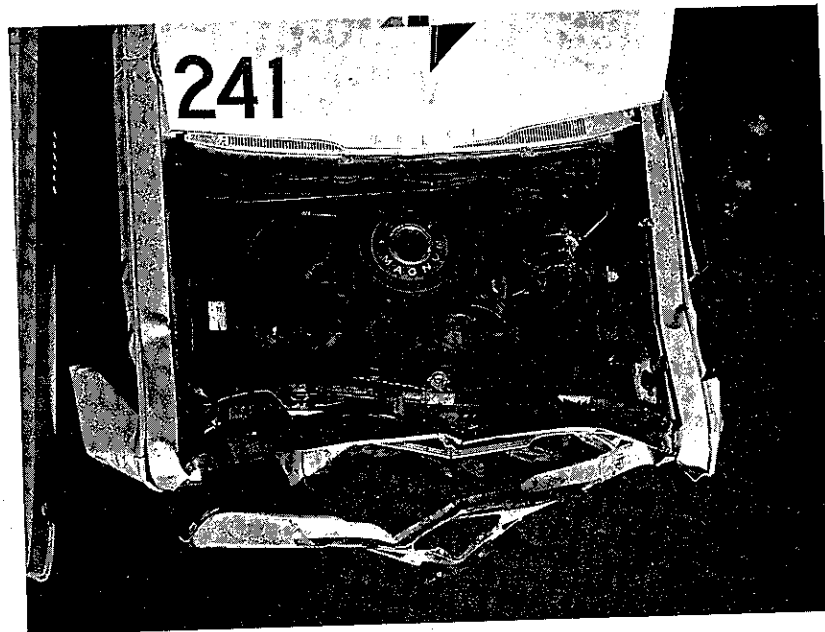
FIGURE 8

Damage was confined mainly to the front end. Maximum significant crush at the center of the vehicle forestructure was 1'-8". The crush was fairly uniform across the front of the vehicle but slightly less on the left side (see Figure 8 and Exhibit 3). The lower frame member, bumper, and front fenders were all severely buckled and the radiator was shoved back against the engine. On the passenger side, the front windshield was cracked where the sun visor came down and was struck by the dummy's head. No crimp in the roof over the doorpost was observed. The doorpost on the driver's side was torn loose from its roof connection and displaced back $\frac{1}{2}$ ". Immediately after impact, the hood flew open. However, it sustained no damage, mainly because the level of the hood was higher than the 2'-6" high barrels at the nose of the barrier. The steering wheel deformation was 2 $\frac{1}{2}$ "; the collapsible steering column was foreshortened 0.7" when the jackknifing dummy hit it.

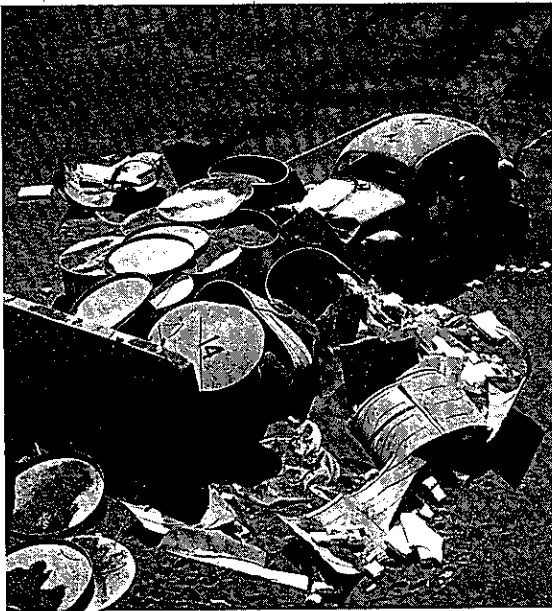
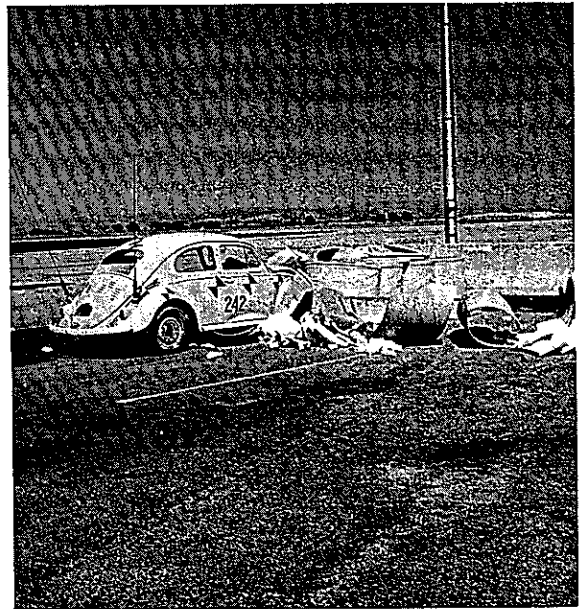
See Plate 5, page 21, for a summary of the test results. The VW hit the barrier nose head-on with its axis about 9 in. to the left of the barrier center line. The impact velocity was 59 mph. The vehicle came to rest 19 ft beyond the nose of the barrier with all its wheels on the ground (Figures 11 and 12). During impact there was a 1'-4" rise at the rear of the vehicle (measured at a target on the right rear fender).

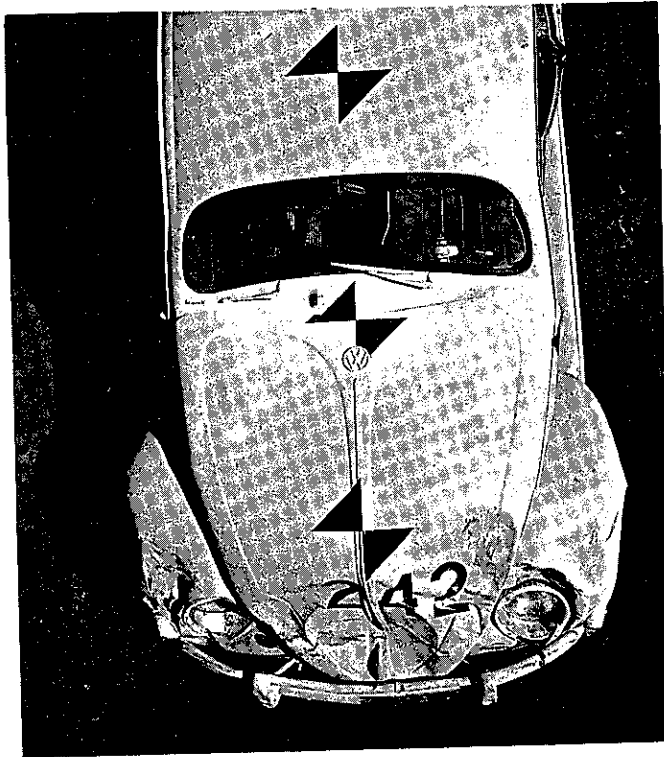
FIGURE 13

The front trunk lid remained closed and was moderately buckled, as were the front fenders. Maximum crush at the forestructure was

only 8 in. (see Exhibit 3 and Figure 13). The entire windshield popped out due to the impact from the dummy's head. The substitution of a pulley for the standard VW steering wheel (required for radio control of the VW) prevented measurement of any steering wheel deformation.

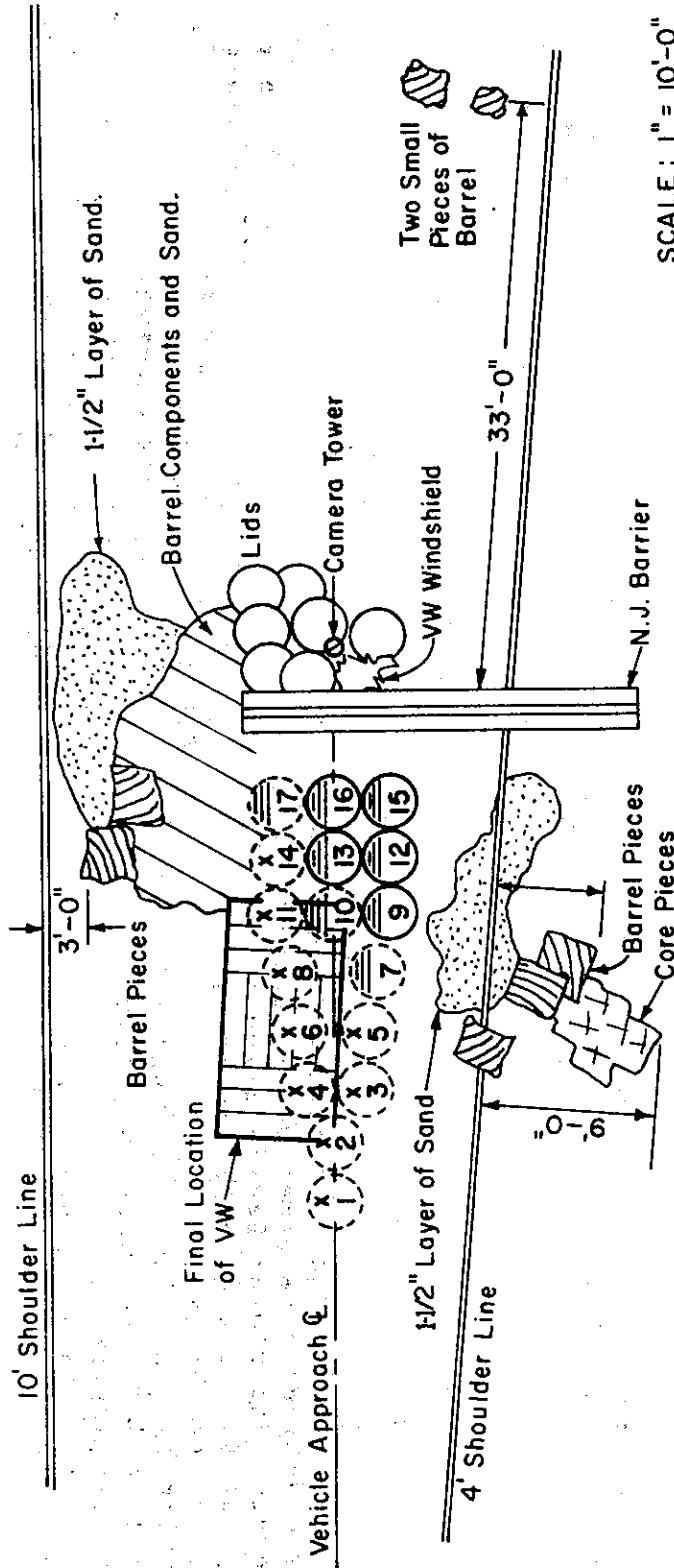
Plate 6, page 22, shows the location of the barrier debris. A small number of barrel core pieces were under the VW but there was no other debris under or behind it. There was no debris outside the 10 ft shoulder line but a small amount extended 9 ft beyond the 4 ft shoulder line. There was no sand covering the front of the VW. Very little debris was found beyond the back of the barrier. The lids all remained attached to the cotton rope and were clustered near the rear of the barrier. At least nine of the barrels were totally destroyed; four or five barrels were compressed but unbroken so they could have been reused; however, some of their inner foam plastic cores were crushed; three barrels were undamaged and undisturbed. The compressed barrels had moved forward during impact; it is unknown whether they could have been dragged on the ground and repositioned without breaking the plastic barrels and cores or spilling the sand.

1. Barrels 9, 12, 13, 15, & 16 were all intact with lids on; two were slightly compressed. No. 16 was 9" from N.J. Barrier.
2. Barrels with an (X) were broken and thrown out of position.
3. All lids remained tied together.
4. Small number of core pieces under car.
5. All 4 wheels of VW on ground.
6. Barrels 7 & 10 were compressed but unbroken, lids were off.
7. Barrel 17 was compressed, unbroken, lid off, leaning against N.J. Barrier.

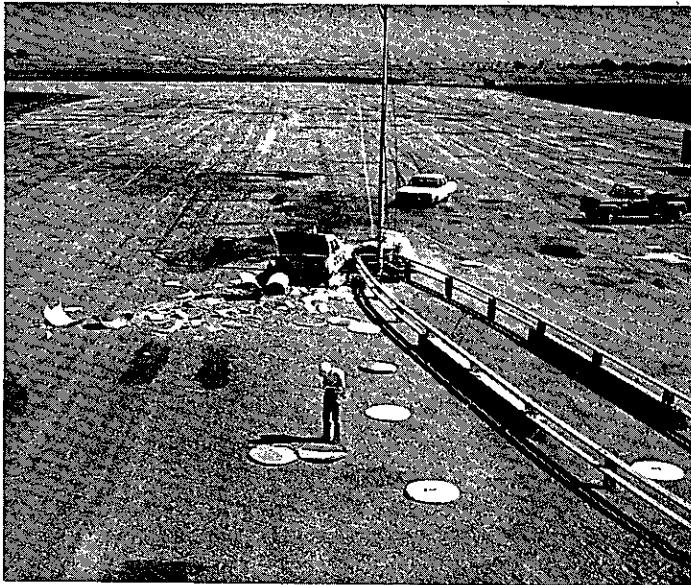
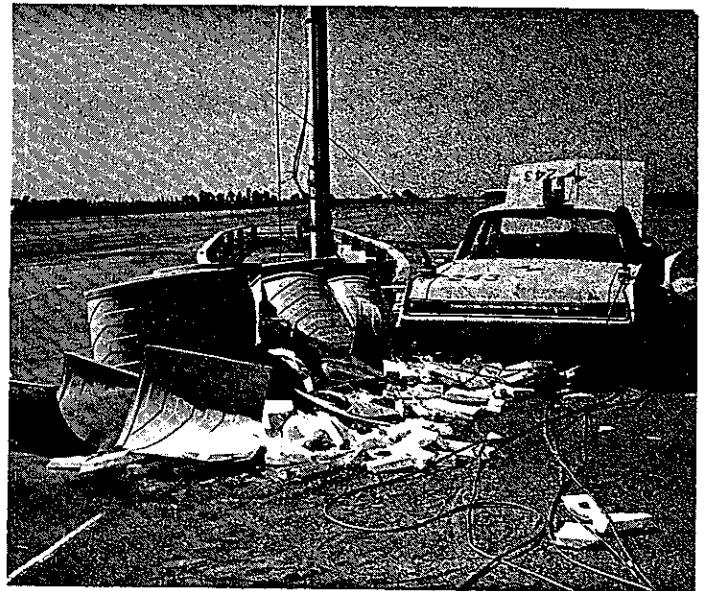
See Plate 7, page 26, for a summary of the test results. The crash vehicle hit the nose of the barrier about a foot to the right of the planned point of impact at a speed of 57 mph and angle of 15° with the barrier axis. It ramped up midway into the barrier and continued on over and through it, narrowly passed by the right corner of the Type 8 bridge approach guardrail nose, and stopped

with the rear of the vehicle even with the last row of barrels in the barrier. It came to rest with all wheels on the ground on a thin layer of sand (Figures 17 and 18).

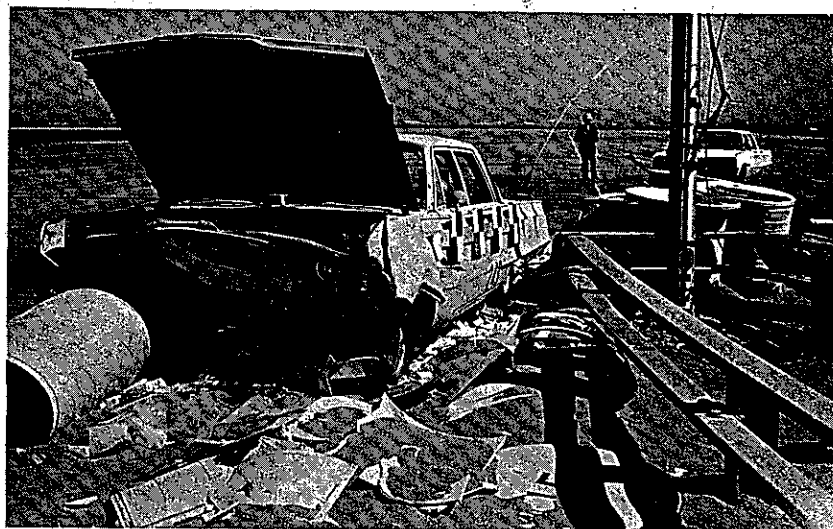
FIGURE 19

Damage to the vehicle forestructure was quite severe (Figure 19). The front end, including fenders, was uniformly crushed back against the engine. The maximum crush was 1'-9" (Exhibit 3). The engine was not displaced. The lower longitudinal front frame members and the bumper were sharply buckled down to the ground and back against the front wheels. The hood was undamaged due to the relatively low 30 in. height of the first four rows of barrels. A

crimp in the roof was observed on the driver's side above the door post. The rest of the car was undamaged. Maximum deformation of the steering wheel was 2-3/4 in. The collapsible steering column was foreshortened 0.75 in. due to impact by the dummy.

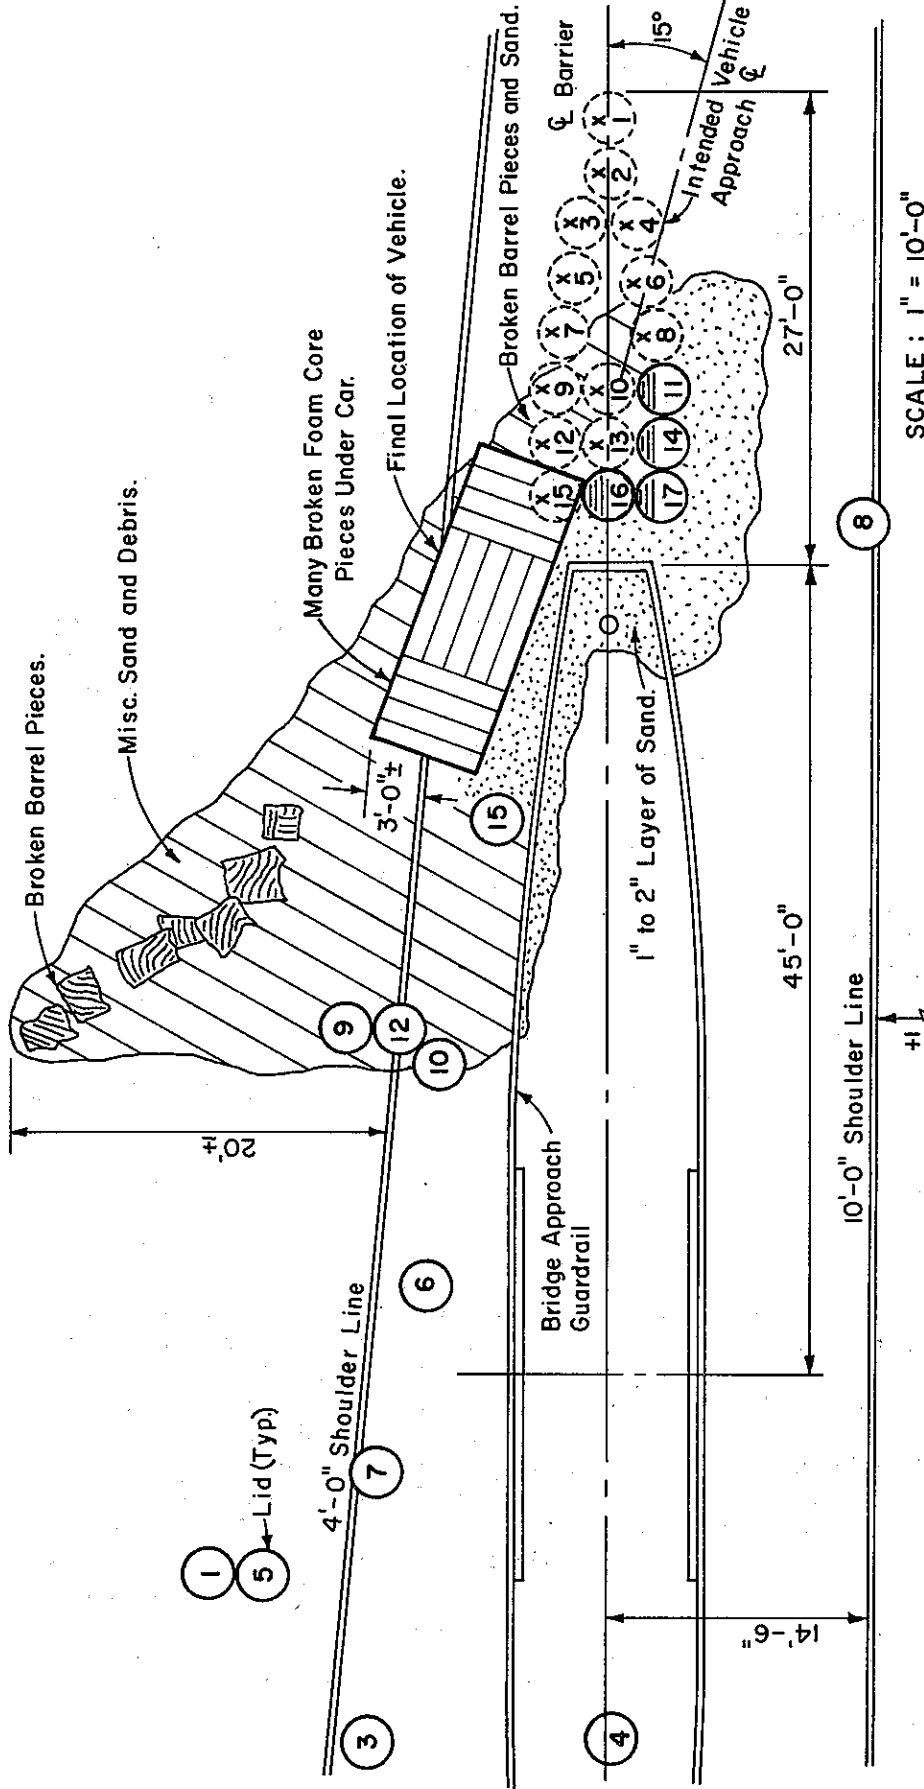
1. Many small, broken foam core pieces blown in all directions by wind.
2. Barrels 11, 14, 16 & 17 still upright, but squashed out of shape with lids still on.
3. Vehicle struck barrier 1 foot to right of intended vehicle approach centerline.
4. x indicates barrel was demolished.
5. Shoulder width measured at last row of barrels.
